# Closed Disposal Site Inspection Report (188)

BKK Sanitary Landfill (19-AF-0001)

4/25/2023

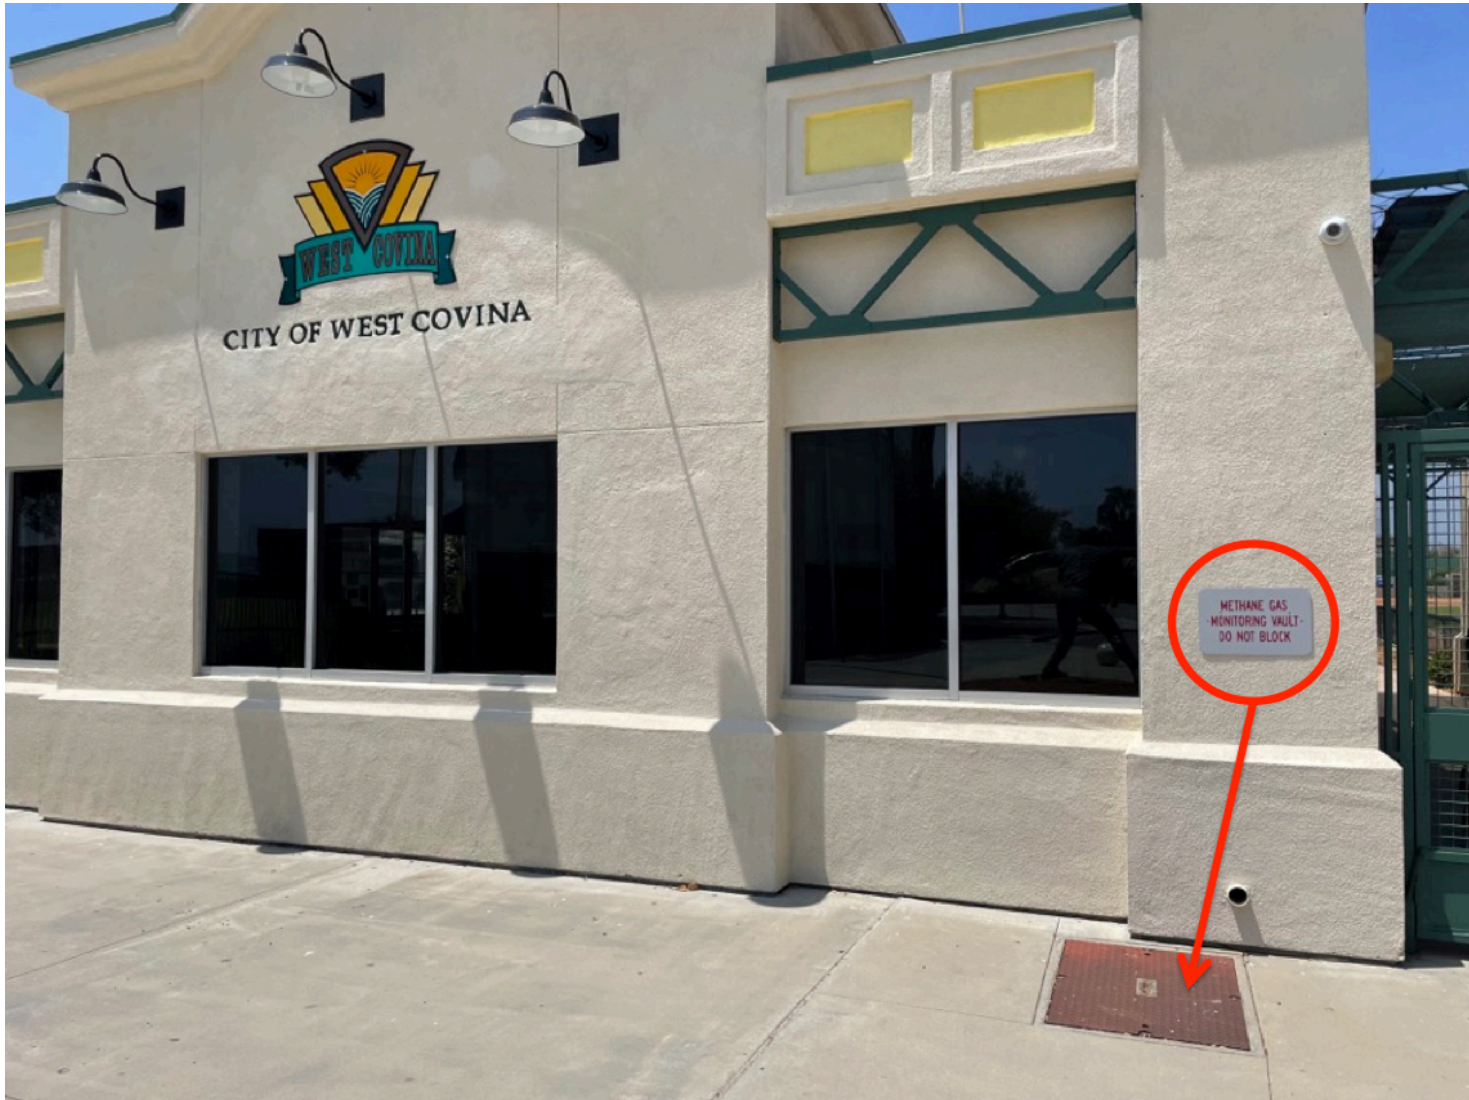
Entrance to the Sportsplex. Sign reads **“METHANE GAS MONITORING VAULT DO NOT BLOCK”**

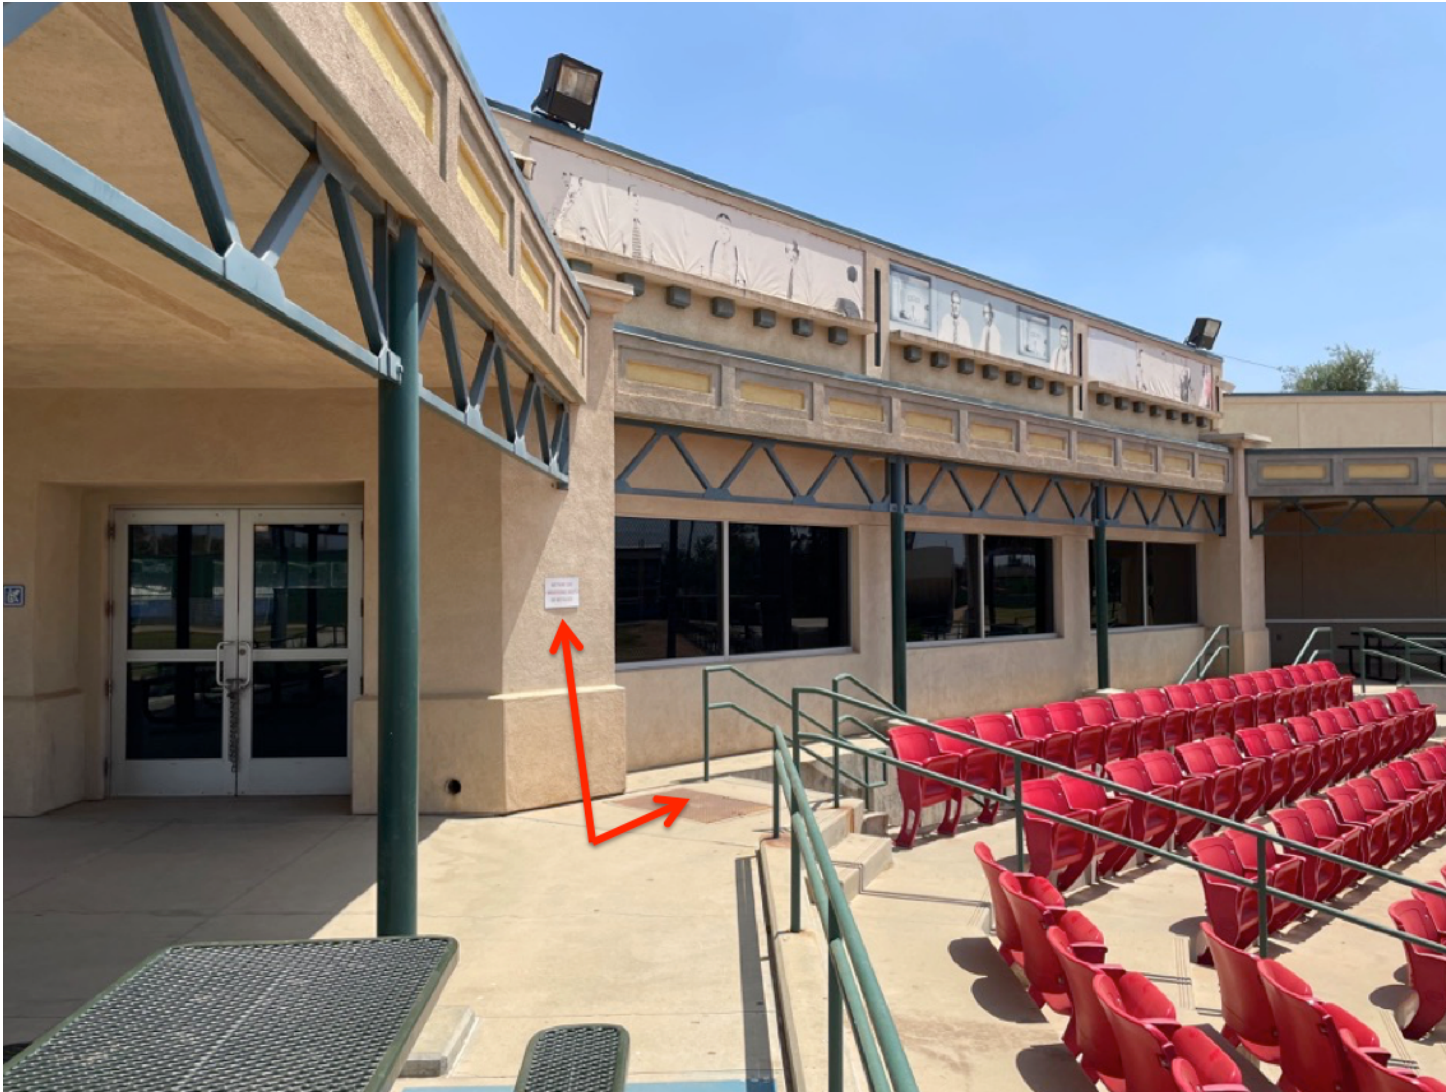
Outdoor seating at the Sportplex adjacent one of the methane sensor vaults and warning signage.

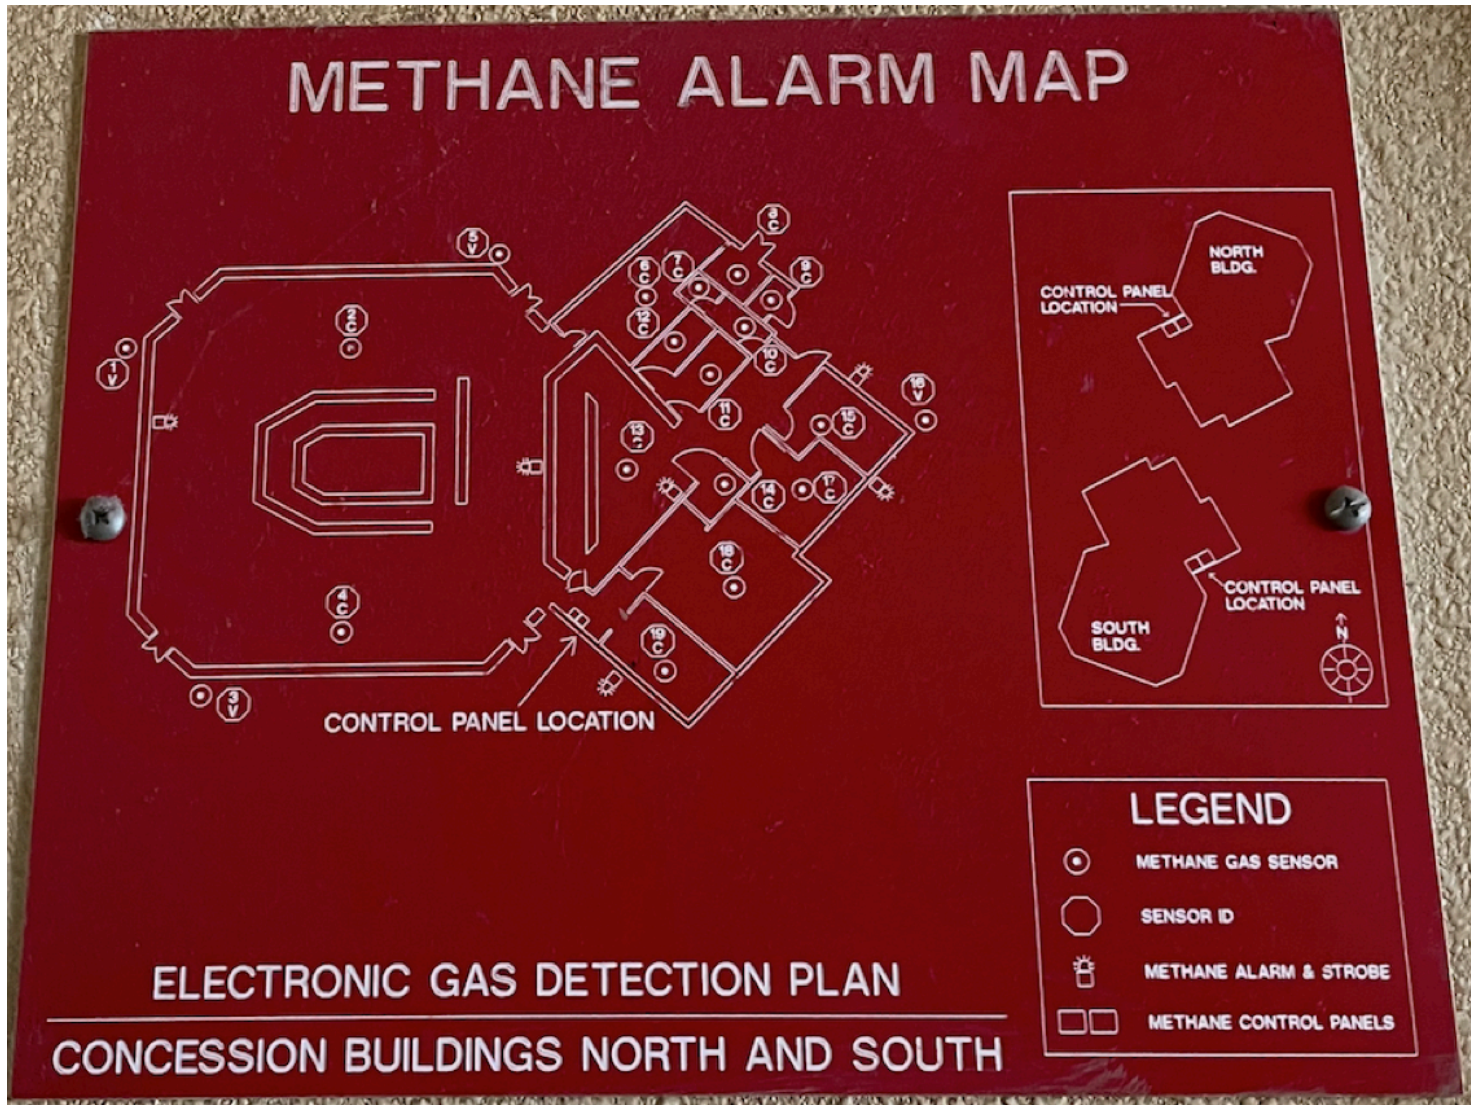
One of the landfill gas safety system maps at the Sportsplex showing locations of some of the sensors, alarms, and control panels
